# Swift BAT Loop Heat Pipe #0 Temperature Droop Problem and Solution after Its Primary Heater Controller Failure

Michael K. Choi\*

NASA Goddard Space Flight Center, Greenbelt, MD 20771

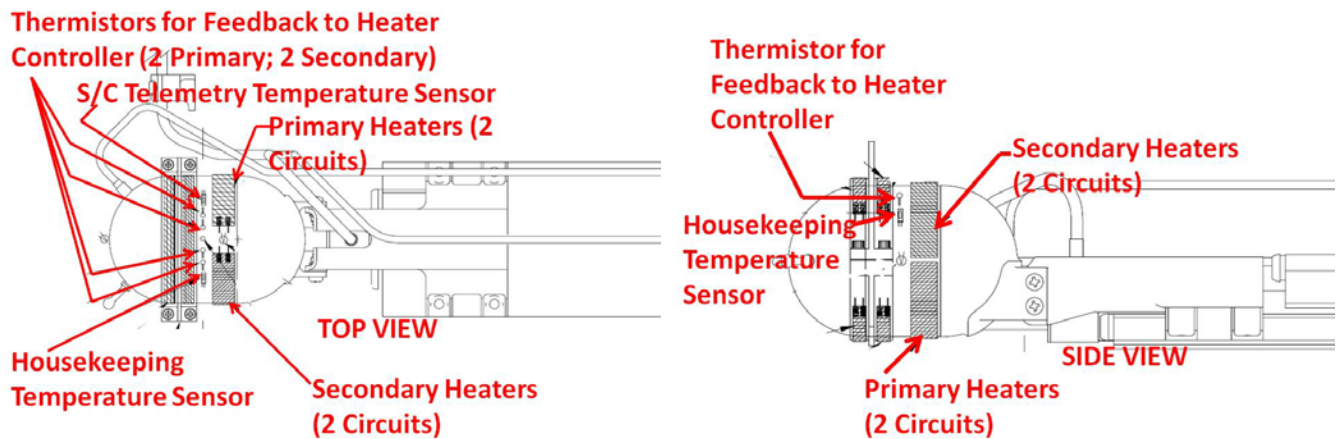
Figure 12. CC Temperature Sensor and Heater Locations.

On April 3, 2010, the LHP #0 primary heater controller was disabled and the set point of LHP #0 secondary heat controller was increased from 6°C to 8°C. From the CC temperature in Figure 11, the secondary heater controller had a significantly larger tolerance than that of the primary heater controller in Figure 8. The AD590 temperature sensor for housekeeping telemetry and the thermistor for feedback to the heater controller are both adjacent to the heater (Figure 12). Secondly the temperature of the liquid return at the CC inlet had a wider range than that before the primary heater controller failed. Thirdly the Block temperature was colder than before the heater controller failure. On April 6, a temperature droop occurred. It recovered in one orbit (Figure 13). Also telemetry BPWHLHPA5TEMP violated the alarm low limit. This temperature sensor measures the temperature of propylene liquid at the LHP CC inlet, where liquid returns to the CC from the VCHP heat exchanger (Figures 14 and 15).
